## **ASSESSMENT OF CAUSE OF HULUKA MICRO HYDRO POWER SCHEME FAILURE AND ESTIMATION OF ITS POTENTIAL**

**Tibebu Tsegaye Zigale <sup>\*1</sup>, Teressa Negassa Muleta <sup>1</sup>, Mubarek Jemal Mohammed <sup>1</sup>**

<sup>1</sup> Department of Hydraulic and Water Resources Engineering, Institute of Technology, Ambo  
University P.O Box 19, Ambo, Ethiopia

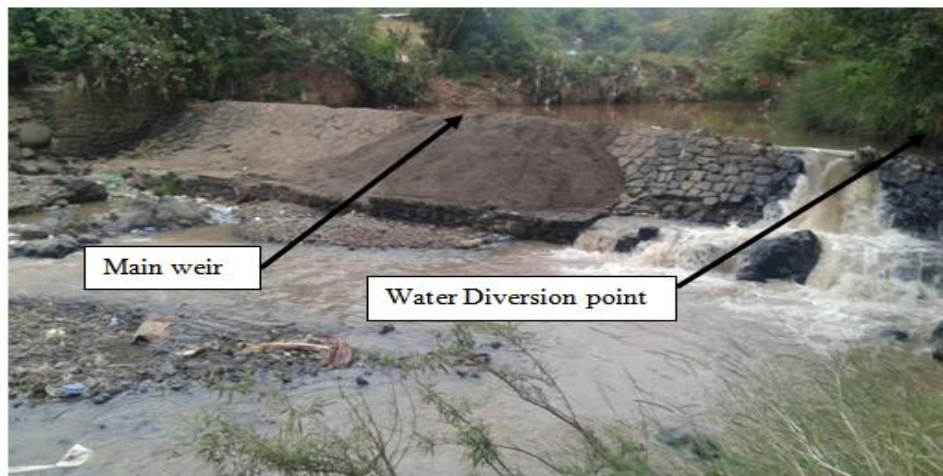
Figure 2: Photo was taken at the downstream side of the Main weir structure

The existing condition of all components of a Huluka micro hydropower scheme was assessed. The researchers found that the main Weir Body made of a masonry structure, with a height of 1.24m, and a top width of 20.15m. The Apron provided upstream and downstream of the main weir to protect the diversion weir foot, and heel from Scouring. Also, the Apron extension of the weir axis to the downstream side measured of about 3.7m, and 0.7m layered thickness, which was observed in good condition and still functional except in a few sections partially scoured. The retaining wall of length 4.7m extended from the axis of the weir to downstream side, a height of 2.9m and a top width of 1.4m found on the right and the left side wing of the Wier in which it is untouched and functional. At the point of water diversion, the head regulator and the Sluice gate installed side by side. However, it was sad to note that their openings clogged by debris, while the steering wheel at the top and shatter gates cutaway no longer existed. So the steering wheel and shatter steel plate should be replaced. The sluice gate has a height of 3.6m and an opening of 0.7m. It's bottom lower than the crest of the main gate, which has a dimension of 3mx0.8m. So now the water is spilling over the weir, and no water enters the headrace canal. The headrace canal constructed of both concrete and masonry. Headrace floor and wall are both lined and unlined one with a length of about 1.5km, the width of 1m, and a depth of about 1m. Its alignment, like most other micro-hydro schemes, runs along the side of the Huluka, and its route is clearly visible except parts of it are buried due to construction cutaway soil and wastes dumped along the canal. The canal almost silted up, some parts of its vegetation grown, filled with sidewall collapse and mass sliding and falling into the canal. As a result, not operational and major rehabilitation required.

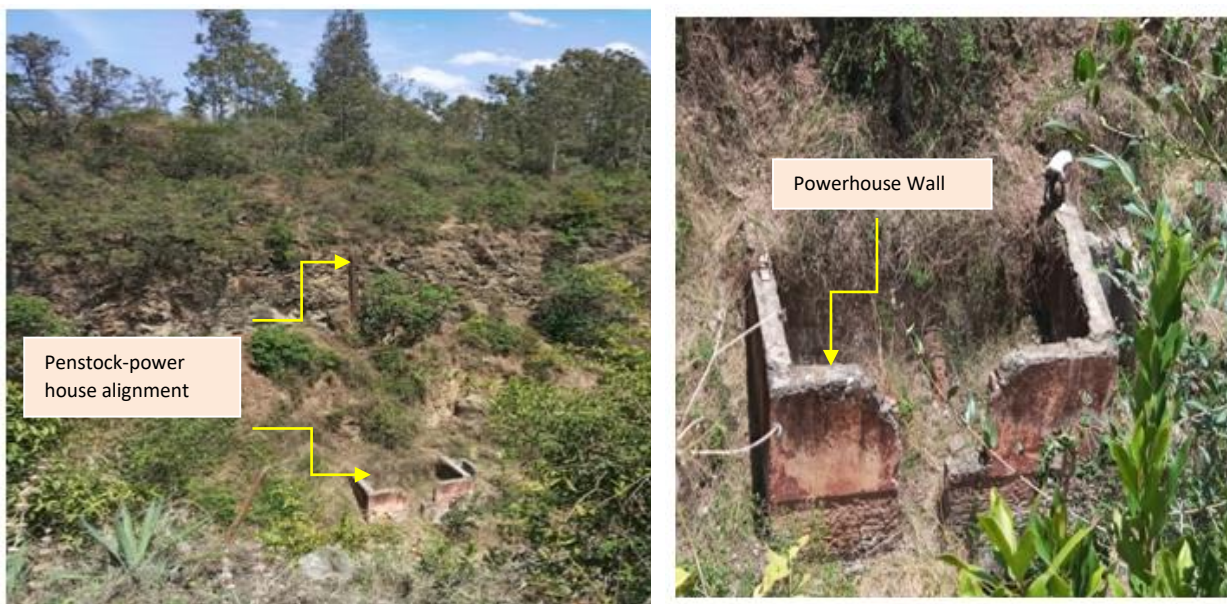
Figure 3: Showing Existing Penstock-Power House Alignment

inclined at an angle of 54 degrees ( $54^0$ ) to the head of the penstock to prevent logging and debris not entered to the penstock. Penstock made of steel has a length of 50.44m and diameter of 0.58m. It is normal except rust on the surface as seen externally and can be set into operation easily with no much cost. The powerhouse is made of a wall from brick materials, partly by concrete and partly by masonry with a wall height 4m and width of 7m. The powerhouse is not being easily accessible as the way from forebay to the powerhouse is too steep and risky. The powerhouse floor is varied, walls collapsed and have no roof. Electro-mechanical components such as turbine, generator power control board and other related accessories are totally removed, and the only power shaft that is fixed to the penstock has existed. So the electromechanical part needs major maintenance and replacement. Tailrace exists, but its outlet is buried and needs maintenance. Generally, some of the scheme components such as weir, forebay, trash rack, and penstock can be set into function with maintenance, whereas the remaining components need redesign and replacement.

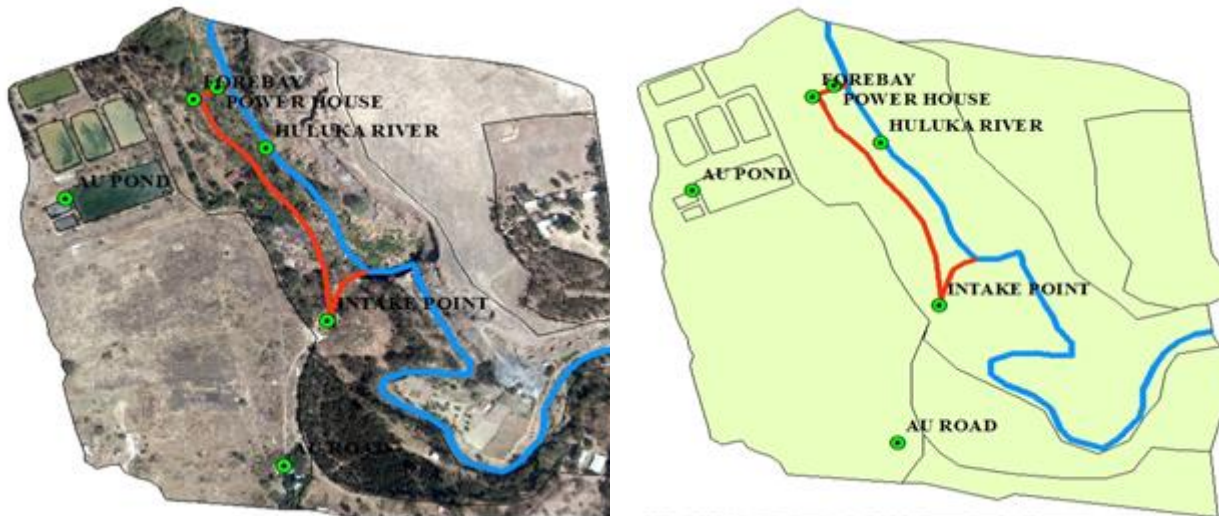
Figure 4: Google Maps showing Huluka river, the Micro-hydropower main components (intake, headrace, forebay, and powerhouse)

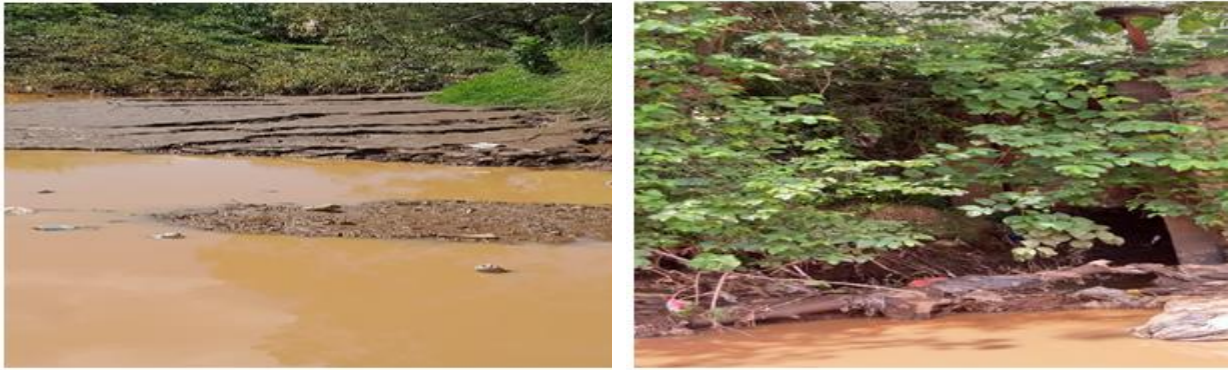
The different measurements, like crest elevations, dimensions, slopes, head, and discharge, have been measured and checked the hydraulic and structural sufficiency. Accordingly, the team identified different engineering defects that had possibly caused the scheme failure. One was the absence of upstream wingwalls or retaining walls, particularly on the left-hand side (intake side) of the diversion structure that could have caused a mass sliding and the closure of the intake structure as shown in the photo below. Similarly, on the left-hand side of the headrace canal, the topography was too steep, in which it should have been retained thoroughly. In addition, the team has observed that Huluka River is known to carry much sediment during the rainy season and sufficient settling basin should have been included in the scheme for further desiltation as it could have possibly clogged the system. Another observation was the absence of the powerhouse roofing. The powerhouse is located in the river course, and due to overflowing on top, it caused damaged and failure of the electromechanical components of the scheme. Furthermore, the damping of excavated materials during constructions in the university might have changed the topography of the canal route as one of the contributory factors of the problem.

Figure 5: Siltation and erosion at upstream of the intake.

The major failures of Huluka micro hydropower were due to siltation, overflowing of water, and lack of repair and maintenance of the structural components. It indicated a maximum annual average flow rate of 7.812 m<sup>3</sup>/s, which shows a good potential rate. Hence, it is suggested the Ethiopian government should not rely solely on the development of large and medium scale hydropower, but it should be included the rehabilitation the existing and developing of the new Micro hydropower to help augment the power problem in the locality.

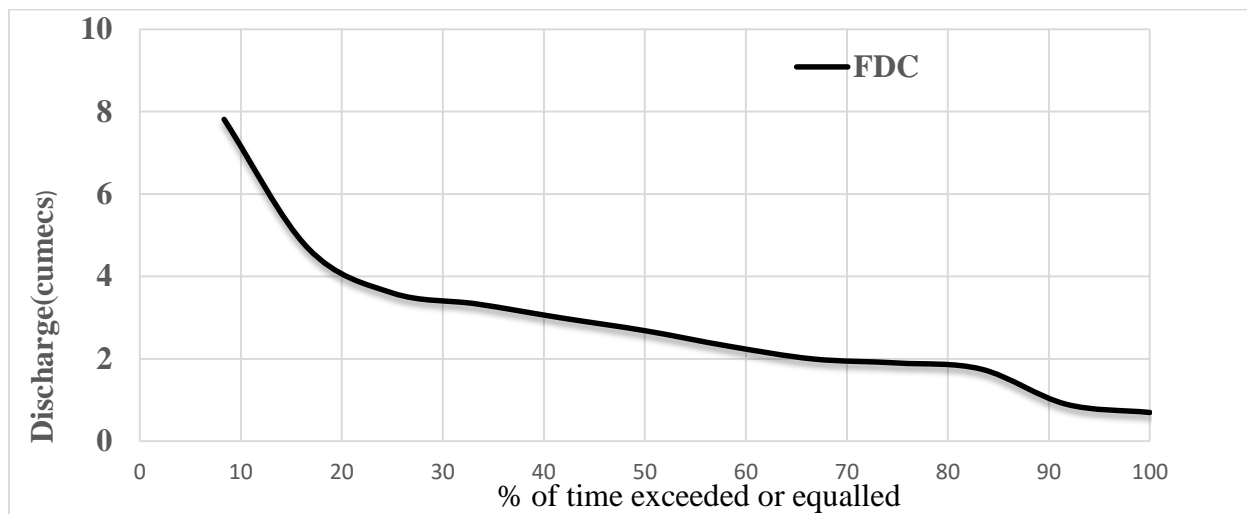
Different potential or theoretical power of the Huluka river micro-hydropower depends on two main parameters, flow and head of the river estimated. The Flow Duration Curve is drawn, and from the curve, the discharge determined out of the different time percentage within the year. The head obtained from a survey made, used for the estimation of potential power. Flow measurement method applied in this research based on the instantaneous daily streamflow from data of eleven years taken from MOIWE and converted to mean annual flow to draw FDC. Within this year of gauged data, the maximum annual average flow indicated 7.812 cumecs. Head measurement with GPS method was not used during the investigation rather than the head measurement method applied using a total station to measure head. The forebay to powerhouse was 37.13m with a gross head weir/intake to the powerhouse was about 40m. Likewise, the estimated maximum theoretical potential power comprised of 1313.23KW. The table below shows the mean monthly flow of Huluka river from 1997 to 2008 Ethiopian Calendar (EC).

Figure 6: Flow duration curve of Huluka River
