Journal of Materials and Engineering Structures

The effect of masonry infill walls on the reinforced concrete frames behavior under lateral load

Ismail Layadi ^{a,b,*}, Ali Messabhia ^a, Jean-Patrick Plassiard ^b, Olivier Ple ^b

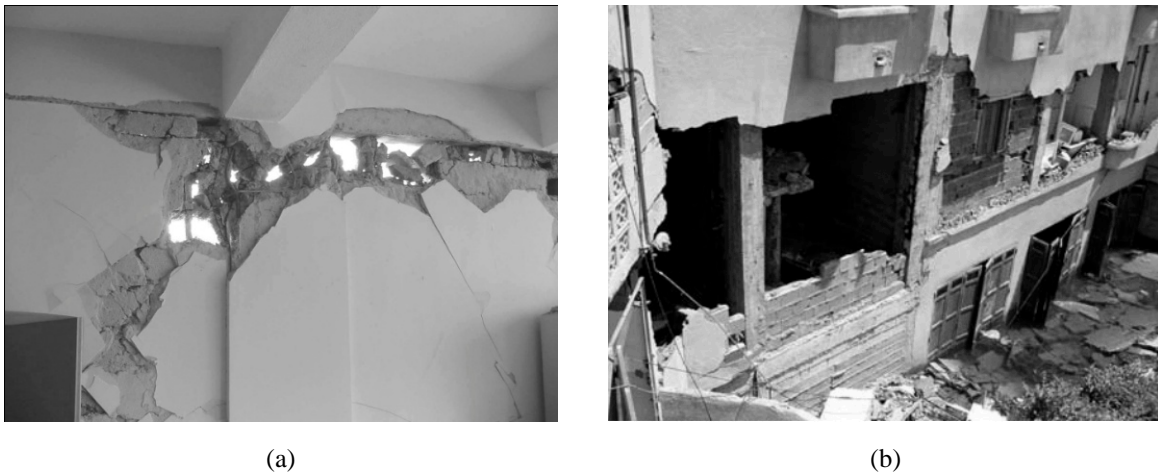
Fig. 1 -Seismic damage in reinforced concrete infilled frames : Bingöl earthquake, Bingöl 2003 [12] (a) and Boumerdes earthquake, Boumerdes 2003 [13] (b)

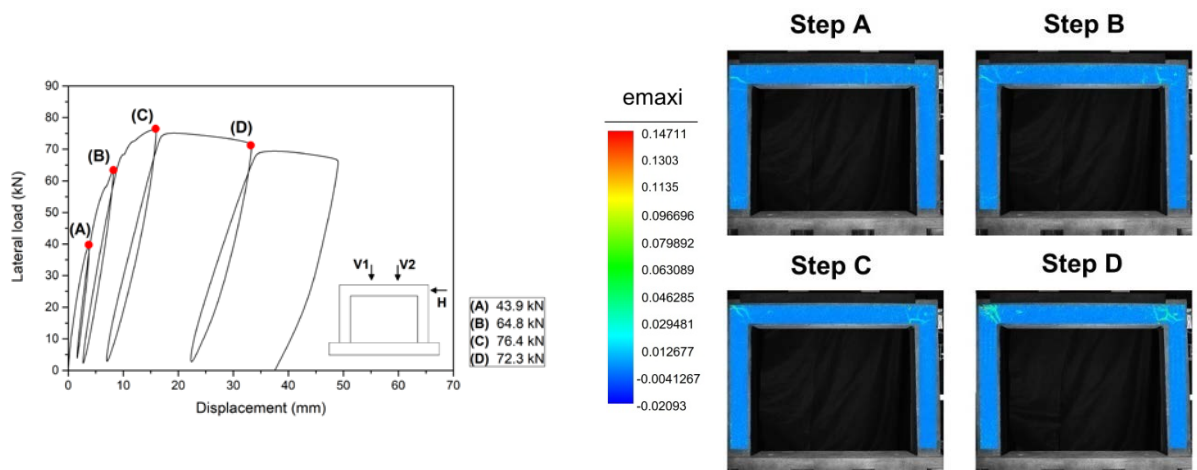
Fig. 7-The DIC strain fields for specimen P.S.02

Using an incremental strain map, the analysis of the results showed a similar deformation mechanism in both bare frames P.S.01 and P.S.02. At step point A (Figures 6-7), cracks were firstly developed in the left beam–column connection. A vertical flexural crack was also observed in the beam near the right beam-column connection for both specimens. Cracks in the right beam-column connection were then developed at step point B. A wider diffusion of cracks in the left side was also highlighted resulting in a more decreased stiffness up to the peak load of 76.1 kN (corresponding to 24.3 mm of lateral displacement) for P.S.01 and 76.4 kN (15.9 mm of lateral displacement) for P.S.02. A localized crack in the already damaged zones at the beam-column connections was then developed leading to the failure of the bare frames due to the flexural mechanism (step point C in Figures 6-7). Except the few flexural cracks that appeared at the bottom of the columns in the case of specimen P.S.02 (point B, Figure 7), no other cracks were observed in the columns of the two bare frames. In fact, both specimens exhibited significant ductility since post-peak resistance underwent a slight decrease, even for the displacements where the order of magnitude is two times larger than that measured at the peak resistance.

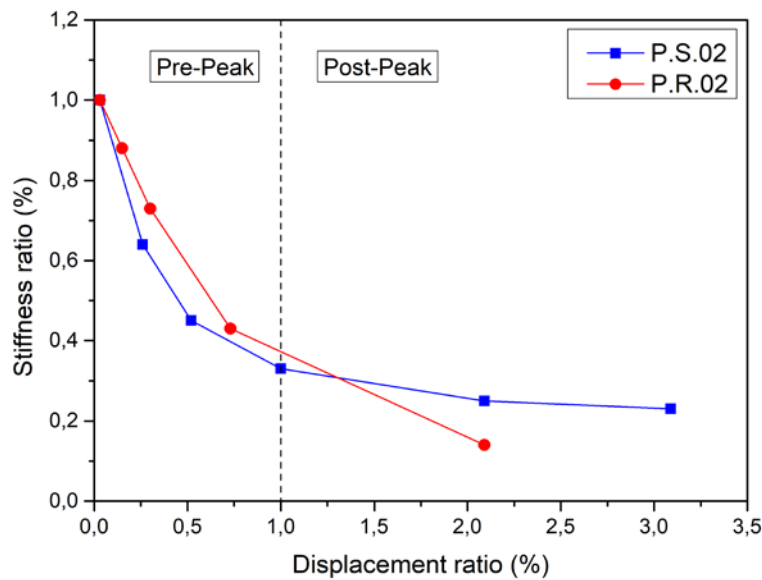
Fig. 12-Stiffness degradation in the loading/unloading cycles

As indicated in Table 4, the initial lateral stiffness K_0 of infilled frames P.R.01 and P.R.02 was 5.3 and 4.4 times that of bare frames P.S.01 and P.S.02. Related results were found in the literature [34], [35]. The secant stiffness K_s of the loading/unloading cycles in specimens P.S.02 and P.R.02 was also calculated considering the slope of the line connecting the extreme points of each cycle. Results are summarized in Table 5. Figure 12 shows the stiffness degradation ratio with respect to the lateral displacement ratio. The stiffness ratio is calculated as the ratio of the secant stiffness for each cycle to the initial stiffness, while the displacement ratio is calculated as the ratio of displacement for each cycle to the displacement at peak level. Significant information can be deduced. First, significant stiffness degradation was observed through the loading/unloading cycles of both specimens (Figure 12). Also, a comparable stiffness loss was found between the two specimens from the beginning of the test up to the peak load level, about 67.1 % and 57.1 % for P.S.02 and P.R.02, respectively. However, P.R.02 underwent a considerable loss in stiffness in post-peak level from 47.6 kN/mm (third cycle) to 15.3 kN/mm (fourth cycle) at about 67.8 % compared to 31.3 % for P.S.02 (from 8.3 kN/mm to 5.7 kN/mm). The excessive damage of the masonry infill wall in the case of P.R.02 was the reason behind losing more stiffness progressively, especially after peak loading (See Figure 12 and Table 5).
