# Journal of Materials and Engineering Structures

### Limitations of cyclic pile load tests by kentledge system in soft clay soil

The paper presents the results of static load tests using the kentledge system on two barrette piles of Tan Cang complex area and one bored pile used in the Lakeside tower, Ho Chi Minh City, Vietnam and discusses the above-mentioned problems.

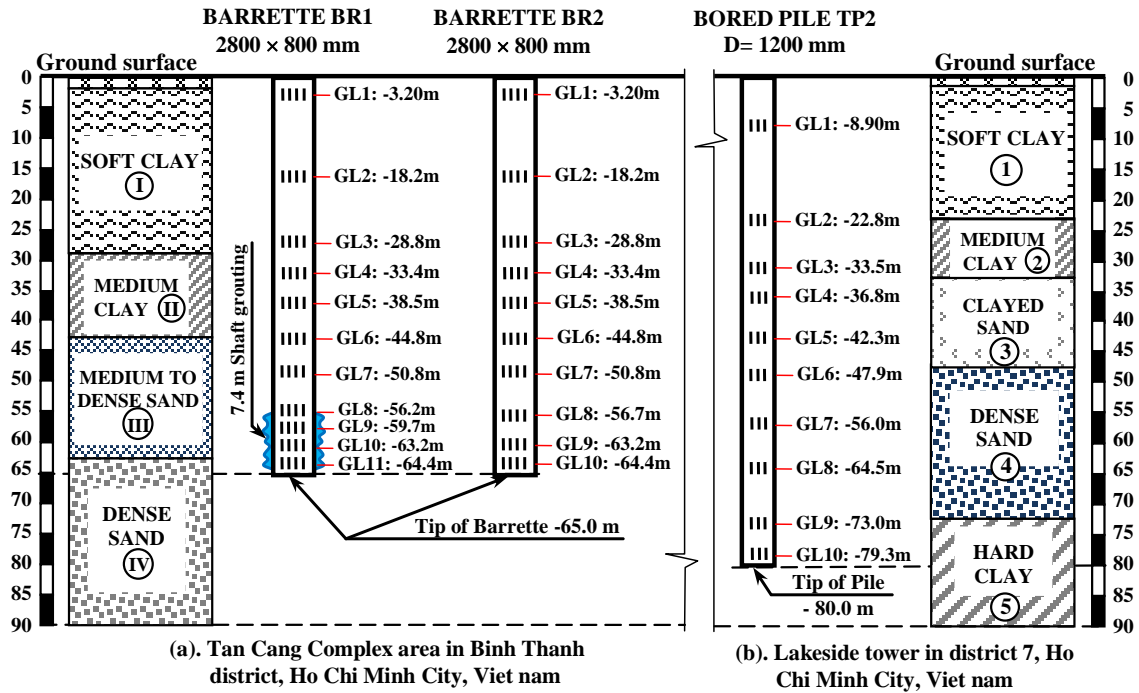
Two test piles (namely BR1 and BR2) in the Tan Cang complex area had a rectangular cross-section area of 2,800 mm by 800 mm and were supplied with a reinforcing cage of forty 25-mm bars, resulting in a steel reinforcement area of 196.3 cm<sup>2</sup> and a reinforcement ratio of 0.88 % for the 2.24 m<sup>2</sup> nominal pile cross-section. These barrettes were constructed to 65 m depth, using grab-bucket excavation techniques with bentonite slurry. Fig. 1a indicates the locations of the strain-gages levels attached along with two barrette piles. Each gage level (GL) contained four strain gauges are arranged at the 4 corners of a barrette cross-section.

Shaft grouting was carried out on the barrette BR1 after completion of concrete placement over about 7.4 m above toe level. To evaluate the efficiency of the grouting technique, Pile BR1 was attached eleven gage levels, which has one more level than that of Pile BR2.

Figure 1 – Details of the instrumented piles

To verify the capacity of the designed piles for the 23-story buildings of the Lakeside project, the bored pile, in 1,200 mm diameter, was installed into 80 m depth on December 04, 2016, to serve the head-down tests using the kentledge system. This pile was supplied with a reinforcing cage of sixteen 25 mm bars (Fig.2a) and instrumented with three vibrating wire strain-gauges on each cross-section area at ten levels below the ground surface as shown in Fig.1b.

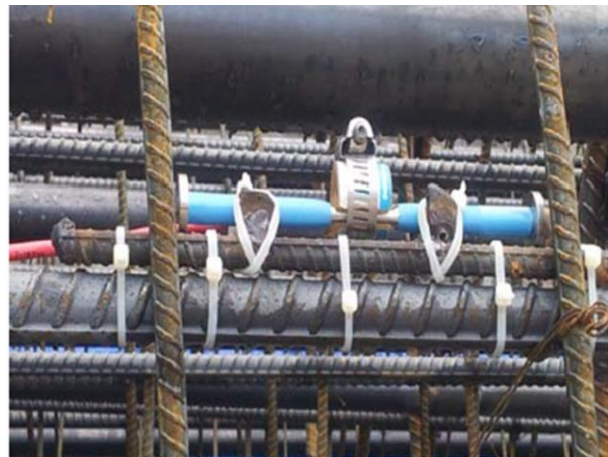
Figure 2 – Details of Pile TP2

(a). Cross-section detail of Pile TP2

(b). Installing a strain gage of Pile TP2

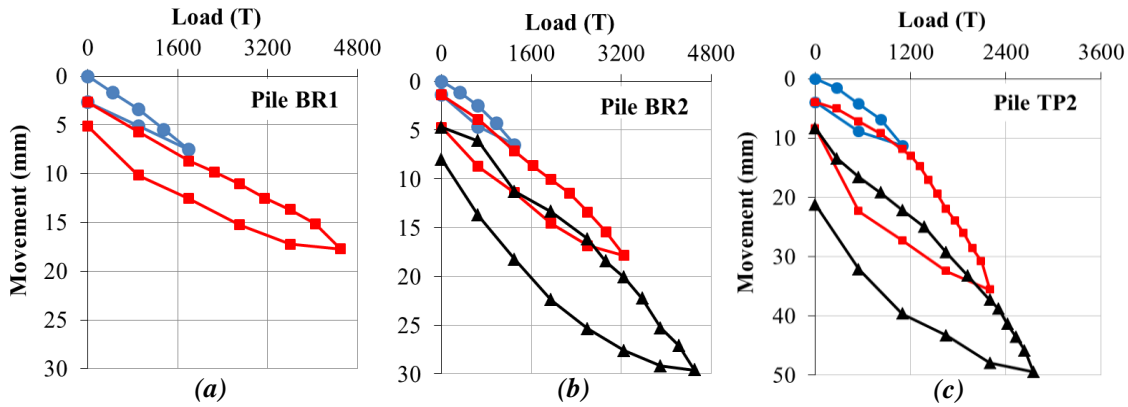
Fig.3 - Load – movement curves of three tested piles

Fig.3 represents the relationship of loads and the pile head movements of three tested piles. The maximum movements of Piles BR1 and BR2 were about 17.7 mm and 29.6 mm, respectively, measured at the same applying load of 4500 T. Besides, the maximum test load and measured settlement of Pile TP2 were about 2750 T and 49.5 mm, respectively.

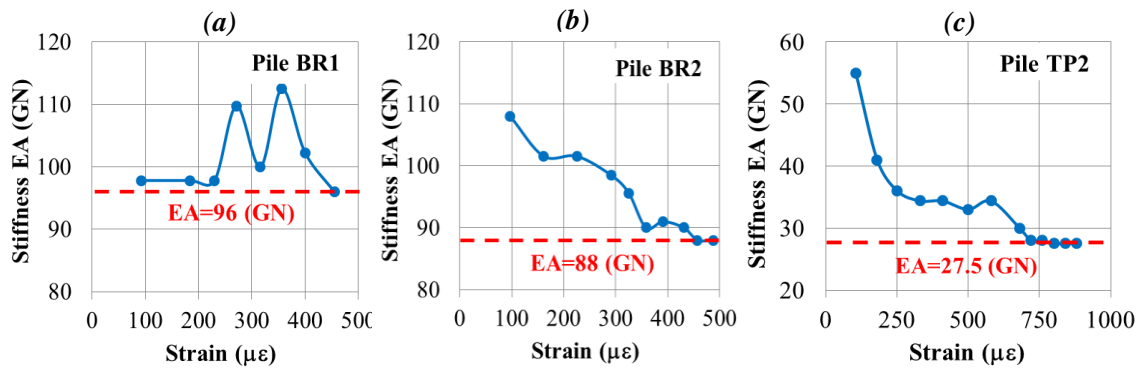
Normally, to convert the measured strain to the load values, it is necessary to know the modulus (E) of the pile material. C. Lam et al. and B.H. Fellenius indicated that one of the best ways of estimating the pile modulus is using a so-called "tangent modulus" or "incremental stiffness" plot, that is, the applied increment of the load over the induced increment of strain plotted versus the measured strain [11-13]. The relationship between the vertical compressive stiffness (EA) and strains are shown in Fig.5 for all studied piles. Note that, only the records of the first strain gages (GL1) were used in determining

the stiffness magnitudes. These curves of Piles BR1, BR2, and TP2 suggested the stiffness values of these piles are 96 GN; 88 GN and 27.5 GN, respectively.

Usually, the modulus of a concrete pile reduces with increasing stress or strain. This means that the relationship between the applying load and the compressive deformation of a pile follows a curve, not a straight line. However, the load-compress graph at the loading phase in Cycle 2 of Pile BR1 is nearly linear, so the value of stiffness (EA) does not change insignificantly, as shown in Fig. 5a. In contrast, over the large strain range imposed during the load tests of Piles BR2 and TP2, the difference between the initial and the final modulus for these concrete piles can be considerable.

Figure 5 – Stiffness plot of records from gage level 1 (GL1) of three tested piles

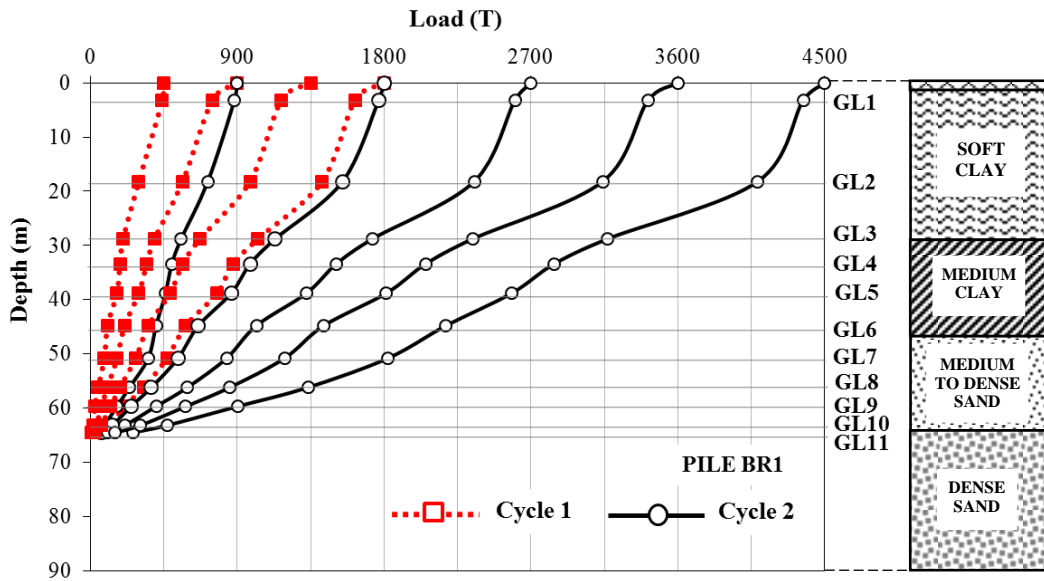
As can be seen clearly in Fig. 6, at the maximum load of 4500 T, the shaft friction of Pile BR1 measured from ground surface to about 28.8  $m$  depth (GL3 level) had become significant to reach the value of 1330 T, which accounted for about 29.6% of the pile head load. Therefore, the average unit shaft resistance of this pile segment is 88.8  $kPa$ . However, the maximum value of base resistance conducted at the end of Cycle 2 was only 259.2 T, which was approximately about 5.7% of the maximum applying load. These values are unexpected and do not accurately reflect the actual shear resistance of the soft clay soil located in the surrounding pile-top and the dense sand layer at the pile toe. Moreover, the comparisons of load distribution along pile shaft of Pile BR1 conducted at the load levels of 900 T and 1800 T clearly show that the load sharing at the same gage levels in Cycle 1 is totally smaller than corresponding results in Cycle 2, because of the residual load caused by the unloading-reloading process.

Figure 6 – Load distribution of Pile BR1

Besides, it is surprised to see that at the same pile head load of 4500 T, the maximum base resistance of Pile BR1 (259.2 T) considerably greater than that of Pile BR2 (158.4 T), although the former pile was used the shaft-grouting technique and

On the other hand, the series of load distribution curves of the tested piles clearly show that the magnitudes of the load distribution at the same level conducted by the equal applied load increase significantly by the loading cycles. It provides more evidence to inform that, using more unloading-reloading phases in the load test processes, consequently, get more the residual loads presented in these piles. Moreover, these residual loads of Piles BR2 and TP2 were accumulated for the reloading of Cycle 3 and it leads to the unreasonable load distribution curves as indicated in Figs 7 and 8. The cycled head-down load tests on two piles that have developed residual load are subjected to negative skin friction along the upper length of these piles, which are resisted by positive shaft frictions in the lower part of the piles and the corresponding toe resistances. So the presence of residual loads will result in an underestimation of toe resistances.

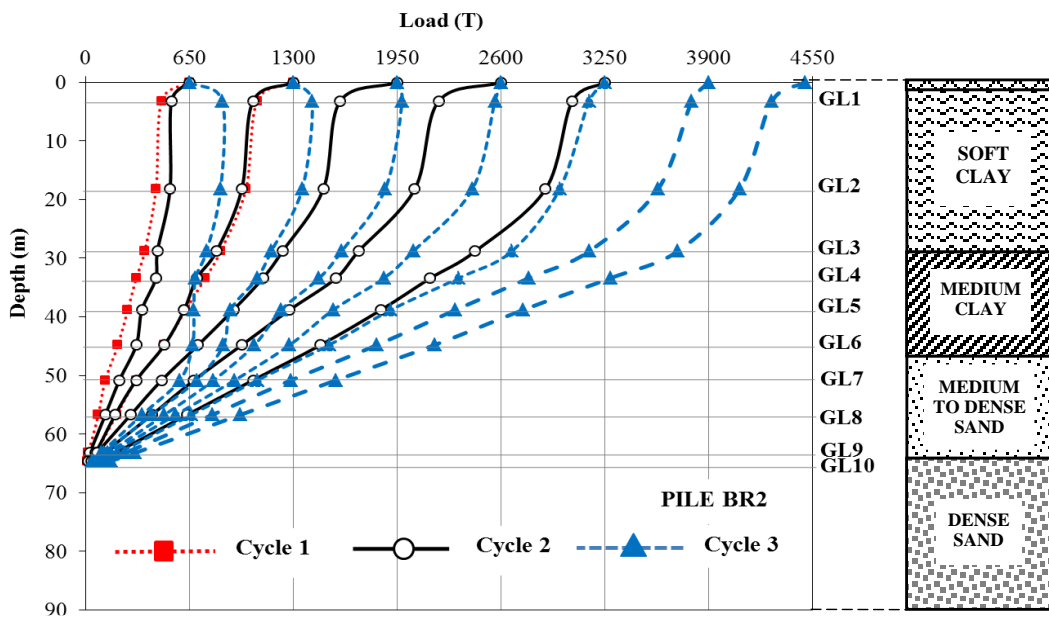
Similarly, the load-transfer curves of Pile BR2 shown in Fig.7 plainly inform that at the maximum load of 4500 T, the shaft resistance of the pile segment located in the soft clay layer was 900 T, therefore, the corresponding value of unit skin friction was 43.4  $kPa$ . However, the biggest value of base resistance was only 158.4 T, which accounted for approximately 3.5% of pile capacity. Note that at the first 3 levels of Cycle 3, the residual loads caused the axial forces at the gage GL1 of Pile BR2 were clearly larger than the corresponding applying loads.

Figure 7 – Load distribution of Pile BR2

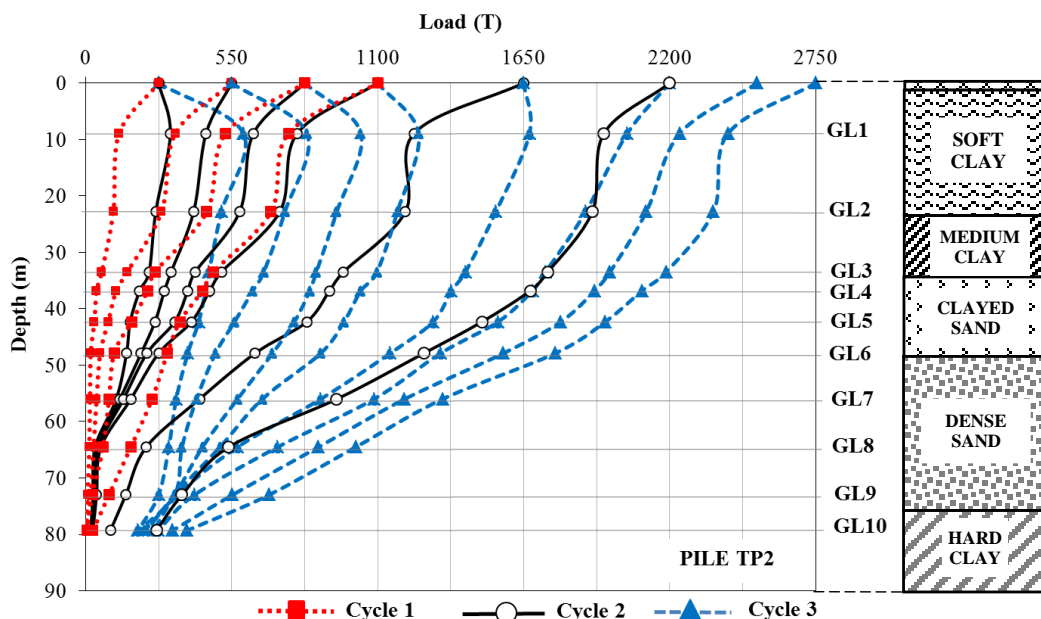
Turning to Pile TP2, the largest pile head load and the shaft resistance from the pile top to the GL2 level were about 2750 T and 386 T, respectively. Thus, the average unit shaft friction of this pile portion equals about 44.9 kPa. This value is markedly greater than expected, because the SPT N-indices of this soil layer is zero, as shown in Tab.1. In contrast, the maximum value of the pile base load was only 382.2 T, and accounted for 13.9% of the working load, despite the fact that the pile toe was located in the hard clay layer. Because of the presence of residual load, the measured loads indicated, falsely, that the soil resistance acting against the pile tip was very small. Also, we can see the irrationality of some graphs in the initial loadings of Cycle 3, because the values of the load distribution at GL1 levels of Pile TP2 are markedly larger than the corresponding loads imposed at the pile head as indicated in Fig.8.

Figure 8 – Load distribution of Pile TP2

The analysis of strain data of three investigated piles informs that setting up the counter-weight of the kentledge system caused the shaft resistances of the pile segments located in soft soil layers to increase from 14% to 29.6% of the maximum-
